Experimental assessment of cracked tubular joints repaired with crack-deflecting holes and weld-toe grinding

S Riise¹, M Atteya¹, O Mikkelsen¹ and G Ersdal^{1,*}

¹ University of Stavanger, Norway

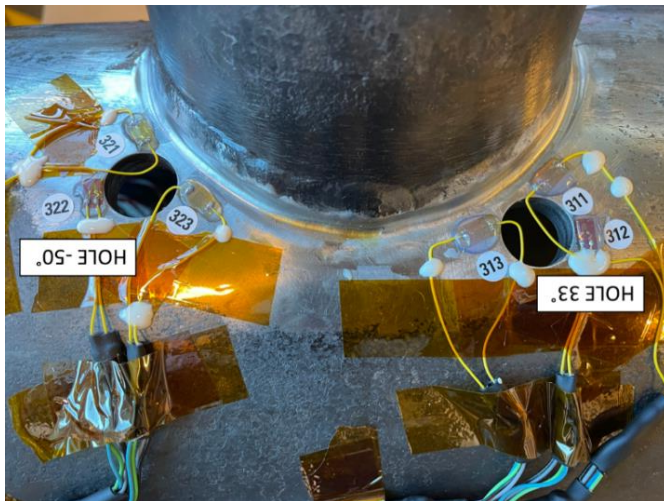
Figure 7. Strain gauge layout in repaired quadrant

After the repair, a set of three new strain gauges was installed around each crack deflecting hole in the repaired quadrant to monitor existing and new crack development. The strain gauge layout in Q3 is shown in [Figure 7](#).

The specimen was repaired by drilling 18 mm holes in the crack tip proximity. Positioning of the holes was made in alignment with Atteya's testing by centring the holes 12° ahead of the crack tip and shifting them 15 mm perpendicular from the weld toe. As the crack spanned from -38° to $+21^\circ$, the holes were placed centred at -50° and $+33^\circ$. The objective of the crack-deflecting holes was to deflect the crack away from the weld toe, which holds significant stresses and arrests the crack in the holes.

In addition to the crack deflecting hole repair, weld toe grinding was performed in Q3 behind the holes. The repair was performed with a rotating "balled-nosed tree" carbide burr with a maximum diameter of 8 mm and was used to grind the weld toe in compliance with BS 7608 [10]. The weld toe was further enhanced by sanding the weld toe in a direction perpendicular to the weld toe with a 240-grit paper, which produced a surface roughness of $58.5 \mu\text{m}$ [11]. Post repair, the emerged weld toe profile exhibited an average depth and radius of 0.5 mm and 3.4 mm, respectively, which aligns with the DNV C203 and BS 7608 specifications.

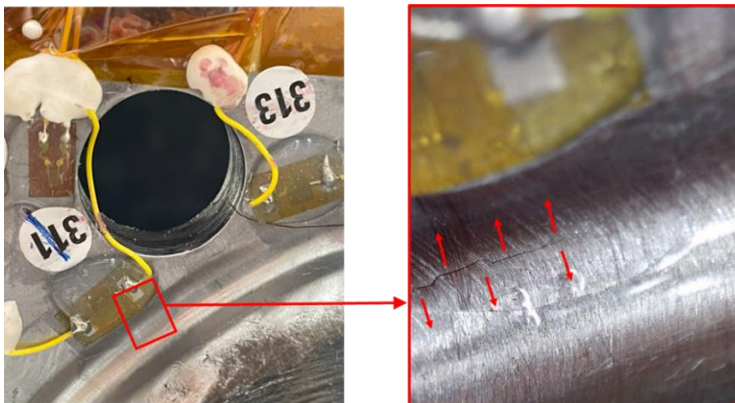
Figure 8. Crack initiation in front of SG crown-side at +33° hole

As per Atteya's discovery, the reverse coalescence phenomenon was present at both the crack-deflecting holes in the specimen tested in this experimental investigation, as shown in [Figure 8](#).

The testing was terminated after 260 000 cycles. At this point, the crack had propagated back into both holes and extended over a total length exceeding 1.5 multiplied by brace diameter marking N4. The fatigue life stages are summarised in [Table 3](#).

Considering the crack initiation beyond the holes and the reverse coalescence phenomenon in the post-repair testing, future work should also focus on optimizing the cut-out repair, as already stated by Atteya [8]. An optimal hole shape, size and placement would decrease the stress concentration even further, making the repair method efficient for tubular joints subjected to higher nominal stress ranges and more extensive degradation.
