Availability of fresh water in Cold climate regions

Awong, Mu Dah¹ and Gudmestad, Ove T. ^{1,2}

Abstract: Challenges related to the availability of fresh water in cold climate regions are discussed with emphasis on possible degradation of the quality of drinking water. The permafrost in this region has been consistent in making sure there is little drainage in the ground. This is important, as fresh water is mainly supplied through melting water from snow and ice in the many winter months. Climate change and warmer weather plays a role in heating up the permafrost and increasing the rate of the melting snow. This has an impact on both the amount of water and potentially the drinking quality. In certain cold region areas, fresh water sources are located not far from the shore. With increased shorline erosion due to warming climate, the fresh water supply are in danger of being contaminated by salt water during large storm events. Furthermore, human activities such as road transport and sewage contamination do also have a significant impact on the water's quality. A bowtie diagram will be used to illustrate the different risk factors and suggestions on how to maintain the quality o

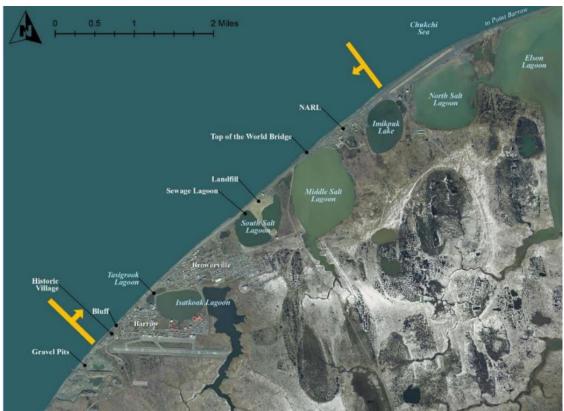
Figure 3. Satellite photo of Utqiagvik (formerly Barrow), Northern Alaska., ^[10]. Note the location of the Isatkoak Lagoon providing drinking water to the town and the Imikpuk Lake previously providing the fresh water to the town.

In the area there are many lakes and freshwater ponds, several of these are located very near to the coastline that is exposed to heavy erosion, [10] and salt-water intrusion. The reservoir providing fresh water to the town, used to be the Imikpuk Lake, however, the lake is contaminated and the Isatkoak Lagoon presently provides the fresh water for the town, Figure 3, although this Lagoon is prone to seawater flooding in case of large storm surges, [10]. It is located at the end of the airport runway.

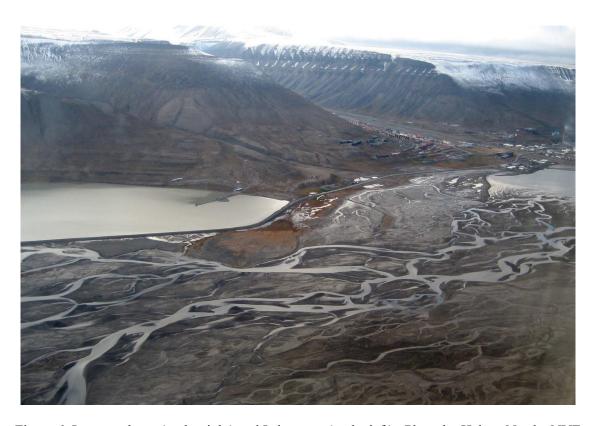
Figure 6. Longyearbyen (to the right) and Isdammen (to the left). Photo by Helena Nynås, NVE

Isdammen is located in Svalbard, east of Longyearbyen and is operated by the local government, Figures 5 and 6. The lake is around 2,5 km long and 0,6 km wide located at an elevation of 14 meters above mean sea level. A 4m high dam keeps the water in place. Its coordinates are 78 degrees N and 15 degrees E. According to the Norwegian Water Resources and Energy Directorate (NVE), the bottom of the lake is made of stone and earth and has an overflow of concrete, [15]. There are numerous sources of water that lead to the lake. Some of the water supply comes from the Endalen watershed. Endalen watershed is composed of various elements, such as rainwater, snow, and ice melt. It also has a moderate mining presence, [16]. This is also true for other watersheds in the area. The lake is next to a cliff which also supplies it with melting water in addition to releasing more sediments into the water.

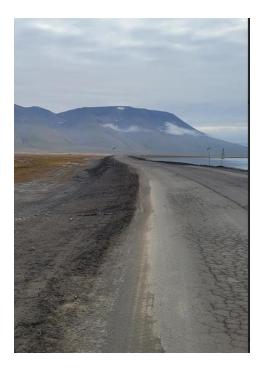
Figure 7. The road passing Isdammen (seen to the right). Photo: O. T. Gudmestad, August 2023.

A road has also been constructed leading to the dam and beyond, Figure 7. At the outlet of the dam to the north, a pump house is built. The water is piped to nearby Longyearbyen. Instead of being buried underground, the pipeline is placed atop of the ground because of the permafrost, [15].
