Internal Clearance Behaviour in Healthy and Faulty Bearings

Idriss El-Thalji^{1*} and Yasmine Khattab¹

¹ University of Stavanger, Norway.

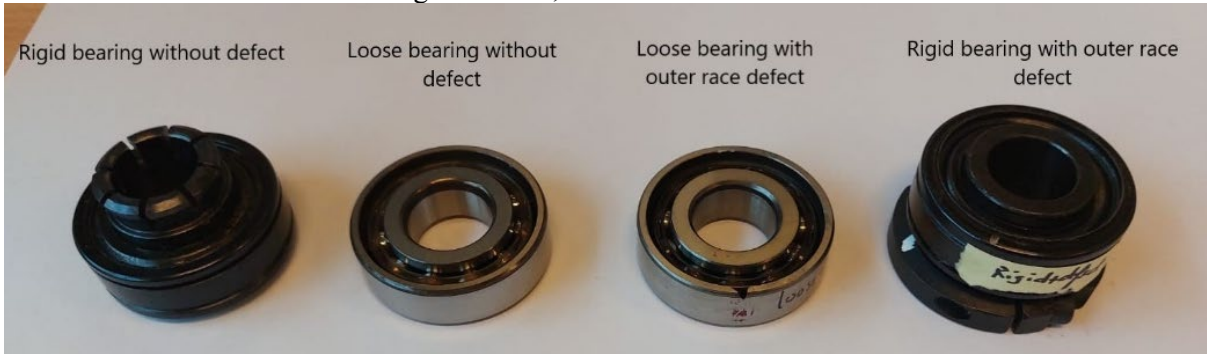
Figure 2. Bearings used in the experiments.

The aim of this experiment is to study the internal clearance effect under healthy and faulty bearing conditions. Under healthy bearing conditions, two types of bearings are considered, one has high internal clearance (internally loose) and the second has no internal clearance (internally rigid), as shown in Figure 1. Under faulty conditions, the same type of bearings were used and an artificial defect was introduced to the bearing outer race, of 2 mm size.

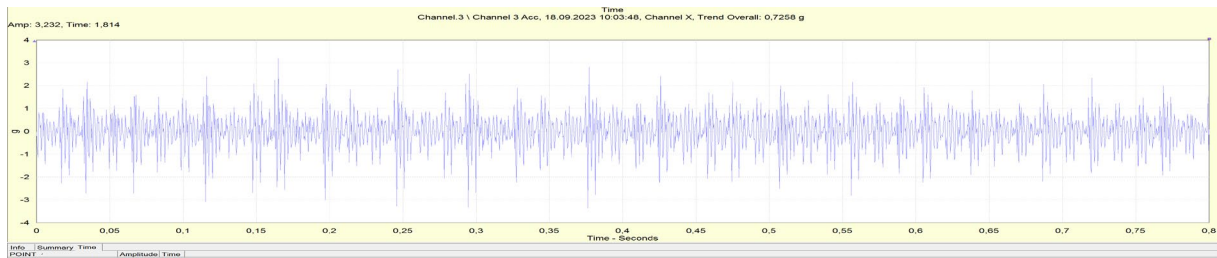
Figure 8. Time waveform for Experiment 2: rigid bearing with outer race defect.

To explain further the effect of internal clearance under healthy and faulty conditions, the time waveform analysis is required. The time waveform shows what physically happened during each experiment. In Figure 7, the time waveform for experiment 1 is presented, where hardly a specific pattern can be captured and amplitudes are of low values (g values between 0 and 0.35). Comparing the time waveform of experiment 2 (Figure 8) with experiment 1 (Figure 7), a clear increase in the amplitudes can be observed (g values between 0 and 3) and a clear impact pattern is observed (impact pulses with almost fixed time interval between them). There are around 60 impact pulses that appeared in one second of the time wave presented in Figure 8. Comparing the time waveform in Figures 7 and 8 provides a good understanding of the effect of bearing defects, especially when the bearing is internally rigid.

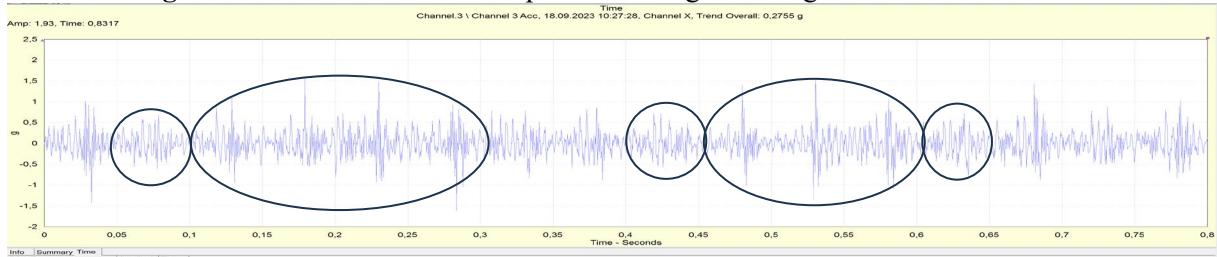
Figure 9. Time waveform for Experiment 3: loose bearing without defect.

To understand the effect of internal clearance, the time waveforms from experiment 1 (Figure 7) and experiment 3 (Figure 9) shall be compared. The time waveform in Figure 9 shows a clear increase in the amplitudes, i.e. the g values are between 0 and 1 compared to the g values in Figure 7 which are between 0 and 0.35. Moreover, there are impact pulses, even though, there is no bearing defect. It can be physically explained as the internal clearness offers a space for the rolling element to vibrate and then hit the race surfaces. However, the hits are not strong like the hits between the rolling element and the defect surface. It can be concluded that internal clearance generates impacts pulses even under healthy bearing conditions.

To understand the effect of internal clearance under faulty bearing conditions, the time waveforms of experiment 3 (Figure 9) and experiment 4 (Figure 10) shall be compared. The time waveform in Figure 10 shows a clear increase in the amplitudes, i.e. the g values are between 0 and 1.5 compared to the g values in Figure 9 which are between 0 and 1. Moreover, the duration of the length of the impact pulses is longer in Figure 10 compared to Figure 9. However, the amplitudes of impact pulses due to the bearing defect are much weaker compared to amplitudes in experiment 2 (Figure 8), which indicates that internal clearance diminishes the effect of the bearing defect. There are around 20 impact pulses that appeared in one second of the time wave presented in Figure 10, compared to 60 impact pulses that appeared in Figure 8. Therefore, it can be concluded that internal clearance affects the impact force severity and passing frequency (rolling elements are not picking the shaft speed as expected).

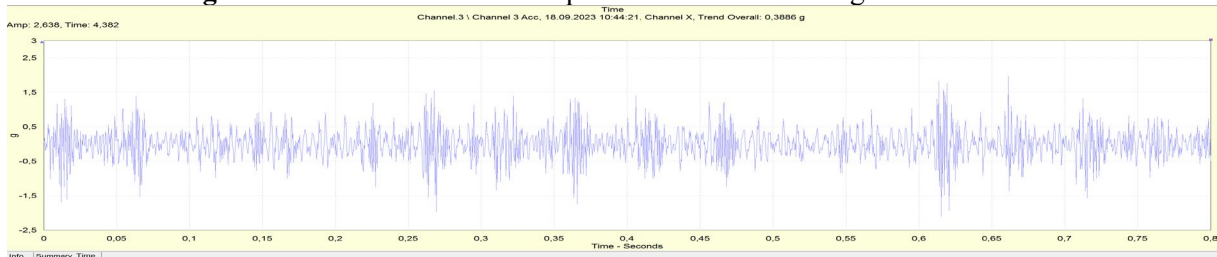
Figure 10. Time waveform for Experiment 4: loose bearing with bearing fault.

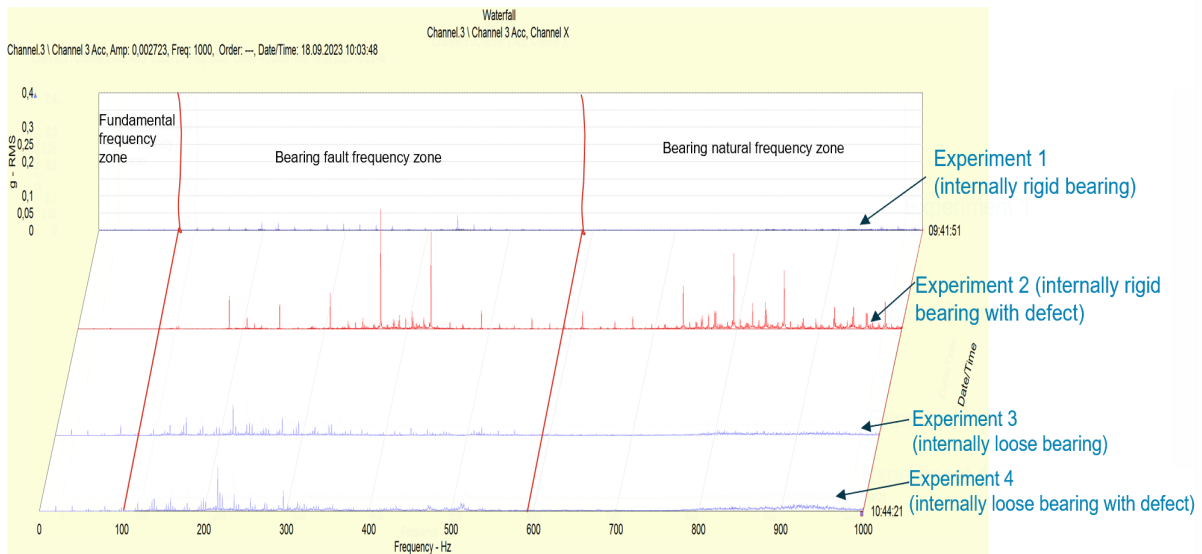
Figure 11. Waterfall plot for the performed experiments.

The internal clearance made the task of detecting bearing fault using time waveform much harder as the impact and rolling element passing frequency were reduced. Frequency domain analysis might provide a better understanding of what happened from a spectral point of view. In Figure 11, the frequency plot for all four experiments is illustrated. There are three main frequency zones that we are going to study to understand the effect of internal clearance on the spectral features: (1) Fundamental frequency zone which is related to the rotating speed (1X) and its harmonics (2X,3X, etc.), (2) bearing fault frequency zone, which is related to the passing frequency of rolling element, (3) bearing natural frequency zone. At the fundamental frequency zone, in the first and second experiments, which are for the internally rigid bearing, there were no bins or peaks shown. However, tiny peaks at 1x (20Hz), 2x (40Hz), 3x(60Hz), and 4x(80Hz) can be seen for experiments 3 and 4, where the internally loose bearings are tested. Having peaks at the fundamental frequency zone might indicate that internal clearance generates shaft imbalance and misalignment. At the bearing fault frequency zone, the internal rigid bearing with fault (experiment 2), shows high amplitude peaks compared to all other experiments. Interestingly, in experiment 4 where a bearing defect exists like in experiment 2, the amplitudes of the peaks are much weaker. At the bearing natural frequency zone, the internal rigid bearing with fault (experiment 2), shows high amplitude peaks compared to all other experiments. It is clear that internal clearance excites the natural frequency of around 800-1000 Hz, however, the excitation is very weak. Let us have a more close look into these frequency zones.

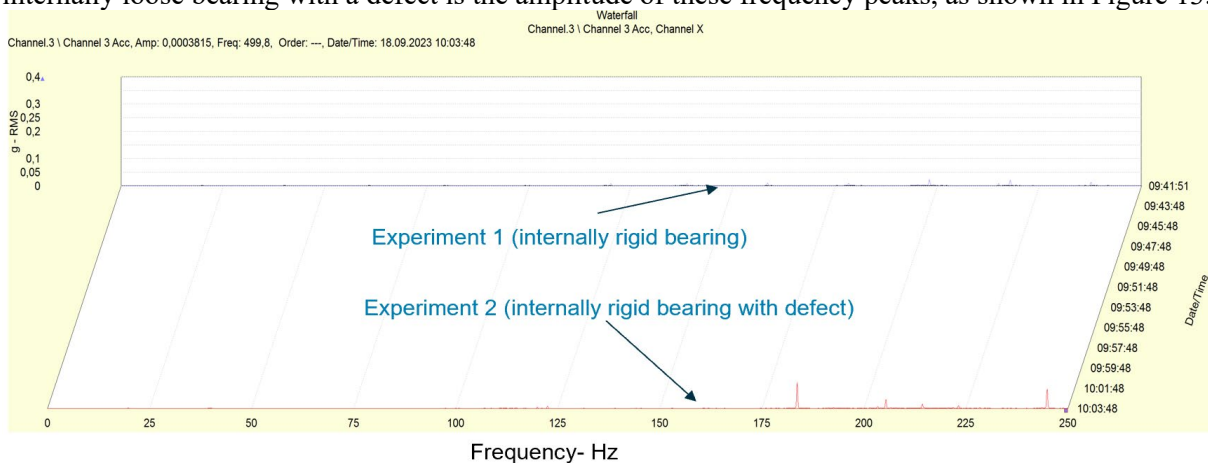
Figure 12. Waterfall plot for the fundamental and bearing fault frequencies zones, Rigid bearing with and without bearing fault.

At the fundamental frequency zone, the internally rigid bearings (experiments 1 and 2) show no bins or peaks up to 100 Hz, as shown in Figure 12. The clear bins appear at 180 and 240 Hz for experiment 2 which might be related to the bearing defect. Remember, we have an outer race-bearing defect, its passing frequency can be theoretically estimated as (rotating speed*number of rolling elements) which is in this case equal to 160Hz (20Hz*8). This equation assumes that the rolling elements pick totally the shaft speed, which is not true. There is a relative speed factor for outer race fault of 40-100%. Thus, the practical bearing fault frequency can be estimated to range between 64Hz and 160Hz. However, the observed peaks are not within this estimated range. Looking at the time waveform of the impact pulses, a clear amplitude modulation exists, which is usually responsible for generating harmonics and sidebands.

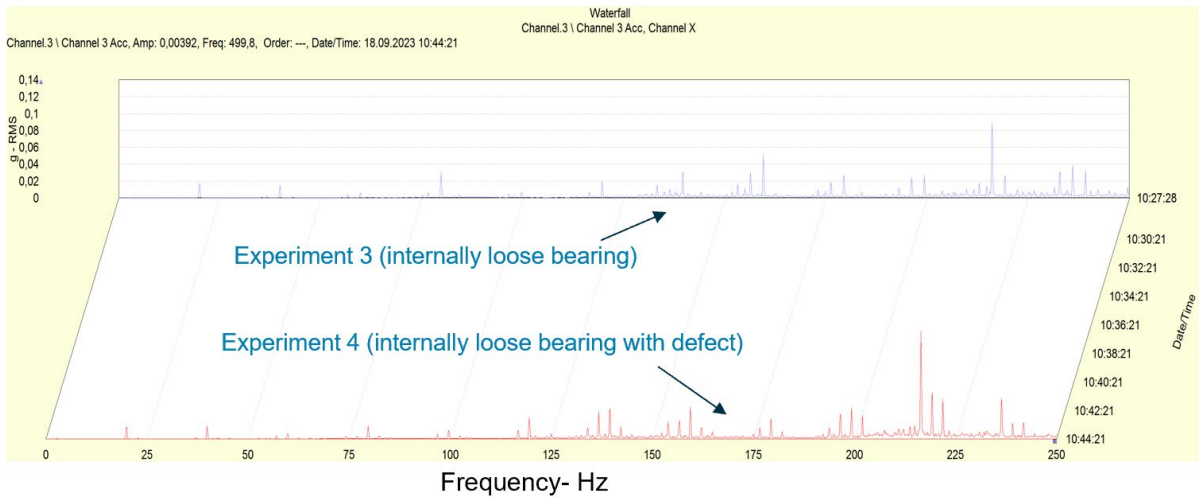
Figure 13. Waterfall plot for the fundamental and bearing fault frequencies zones, loose bearing with and without bearing fault.

The internally loose bearings (experiments 3 and 4) show bins or peaks up at fundamental frequency (20Hz) and its harmonics 40, 60, 80, 100, 120, 140, 160, 180, 200, 220, and 240 Hz. However, the highest amplitude is at 220Hz. The estimated outer race fault frequency for bearings in experiments 3 and 4 is a range of 88-220Hz (20Hz*11 rolling elements). It can be concluded that internal clearance generates spectral peaks from 2x to 12x. The only difference between an internally loose bearing and an internally loose bearing with a defect is the amplitude of these frequency peaks, as shown in Figure 13.

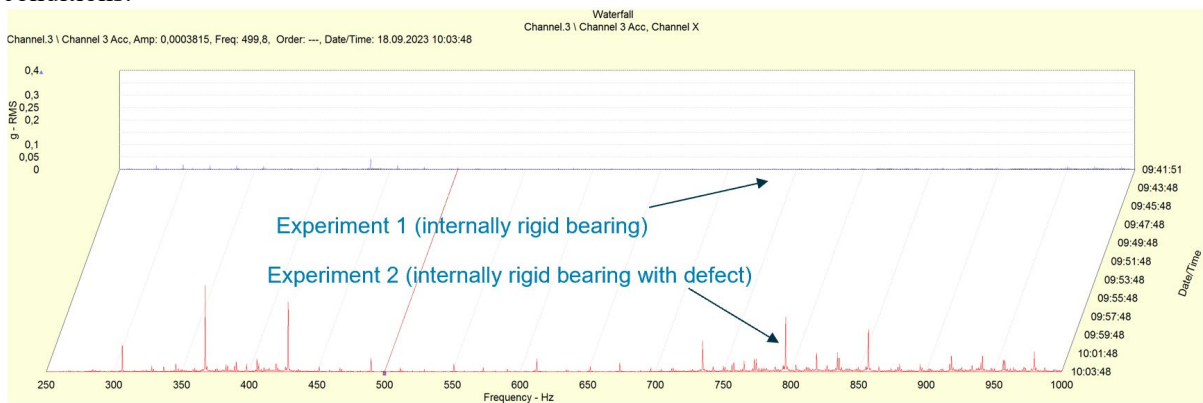
Figure 14. Waterfall plot for the natural frequencies zones, internally rigid bearing with and without bearing fault.

At the bearing natural frequency zone (700-1000Hz), the internally rigid bearings (experiments 1) show no bins or peaks, as shown in Figure 14. However, there are clear bins at the natural frequency zone in the case of experiment 2 (Figure 14), as the impacts of the bearing defect on the bearing defect area excited the bearing natural frequency. For internally loose bearing (experiment 3), it is expected to have no excitation at the natural frequency zone, same as the case of experiment 1. However, there is a clear excitation in Figure 15, from 750Hz to 1000Hz. It physically means that the rolling element vibration due to the internal clearances generates minor impact events that lightly excite the bearing natural frequency. In the case of experiment 4, the excitation at the natural frequency zone (750-1000Hz) is a bit higher compared to the one in experiment 3, however, it is much lower compared to the one in experiment 2. It physically means that bearing defect under internally loose conditions excites the natural frequency, however, the effect of bearing defect is much higher under internally rigid conditions.

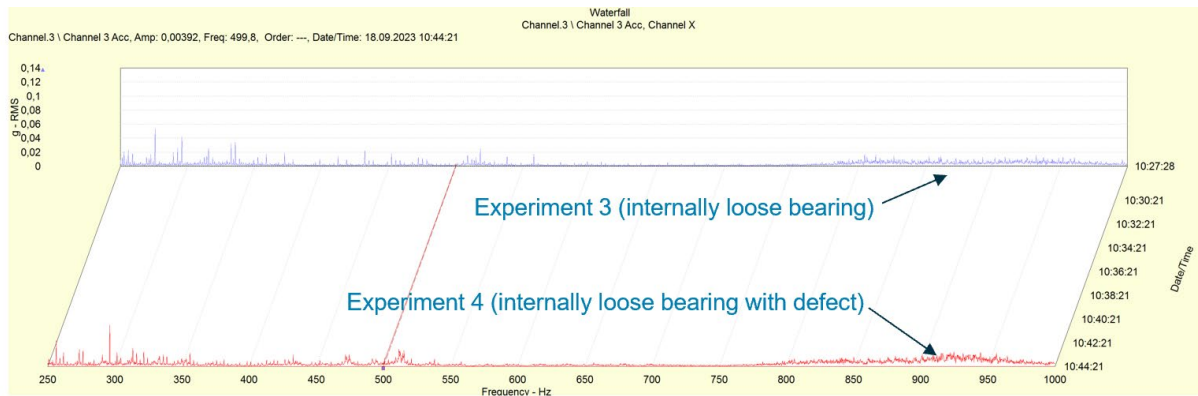
Figure 15. Waterfall plot for the natural frequencies zones, internally loose bearing with and without bearing fault.
